**Black Bear Cub Fire: March 17, 2013  
Sevier County, Tennessee**

**Prepared by:**

**Stephen Quarles  
Insurance Institute for Business & Home Safety  
Richburg, SC**

**February 3, 2016**

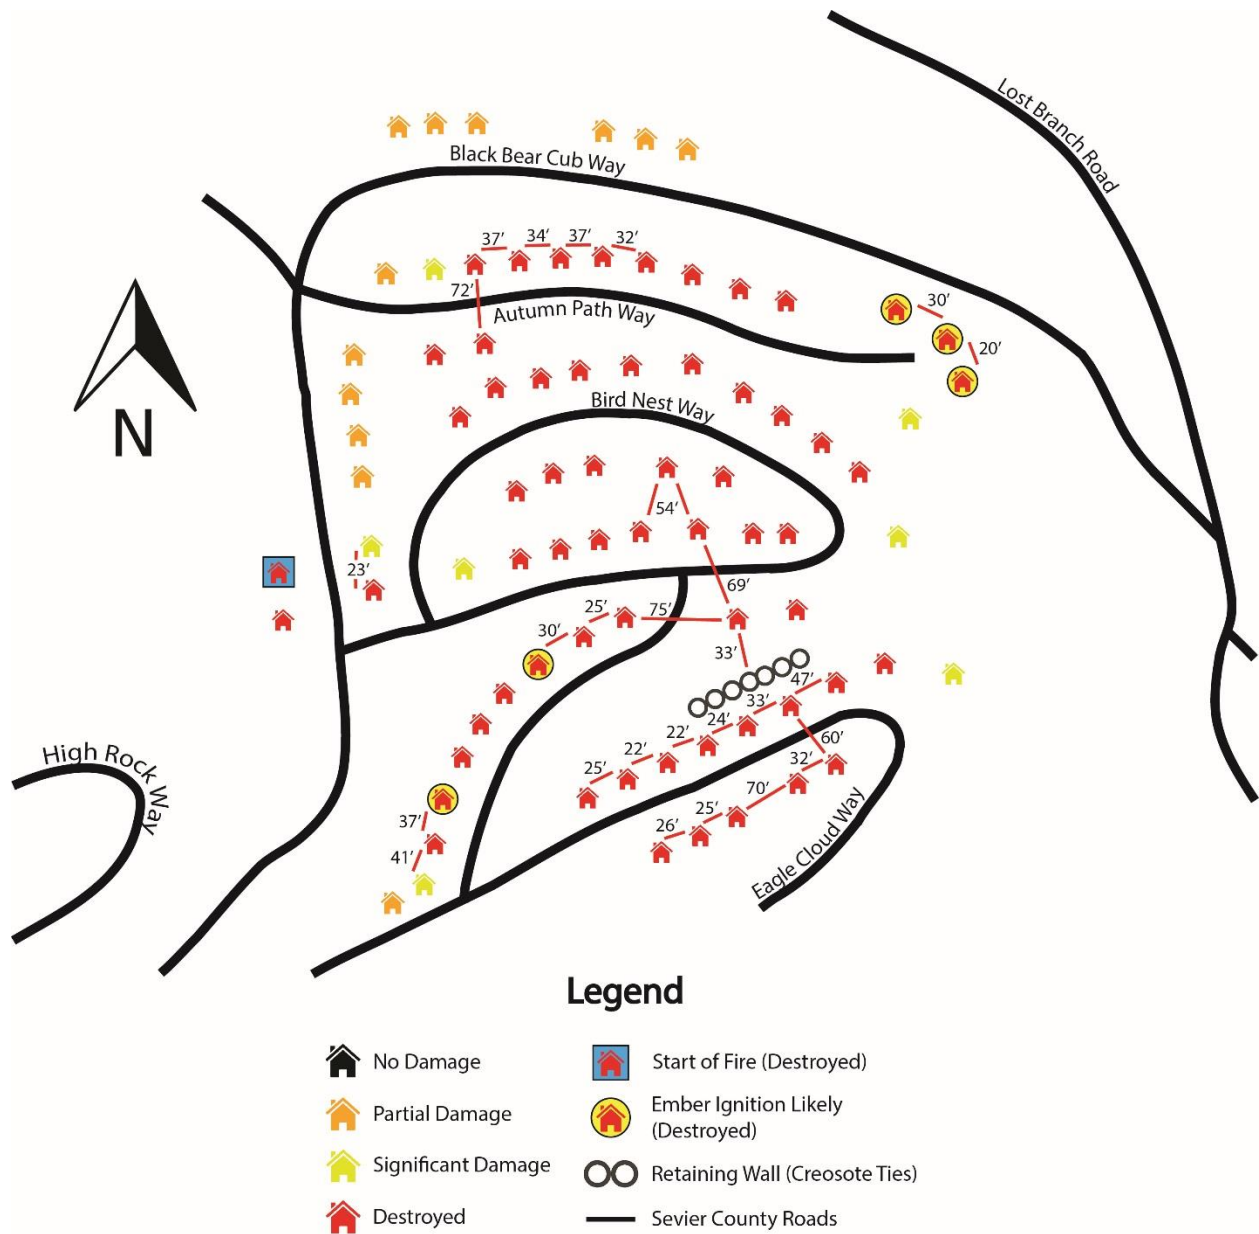
Between-cabin distances measured during the site visit are shown in Figure 1. Between-cabin measurements that include estimates based on an April 11, 2012 Google Earth image are shown in Appendix A. The average side-to-side cabin spacing (of those measured on-site) was 32 feet. This distance is greater than the approximate 15-foot between-building separation reported in some post-fire assessments where home-to-home fire spread has been common. As shown in Figure 1, the fire in the BBRR development was thought to have started on the deck of a cabin on Black Bear Cub Way. Fire spread to the cabin to the south via a radiant heat exposure seems likely. Damaged and destroyed cabins to the east of these initial starts are approximately 80 feet away, making a radiant heat exposure, exclusively, less likely. The same can be said for two of the following three subsequent ignitions, where, continuing to the east, between-cabin separations were between 50 and 70 feet. Wind-blown ember and/or flames were also contributing.

**Figure 1.** Between cabin distances measured during the April 26 site visit. Based on reports from the Gatlinburg–Pigeon Forge Airport automated weather observing station, winds were from the southwest.

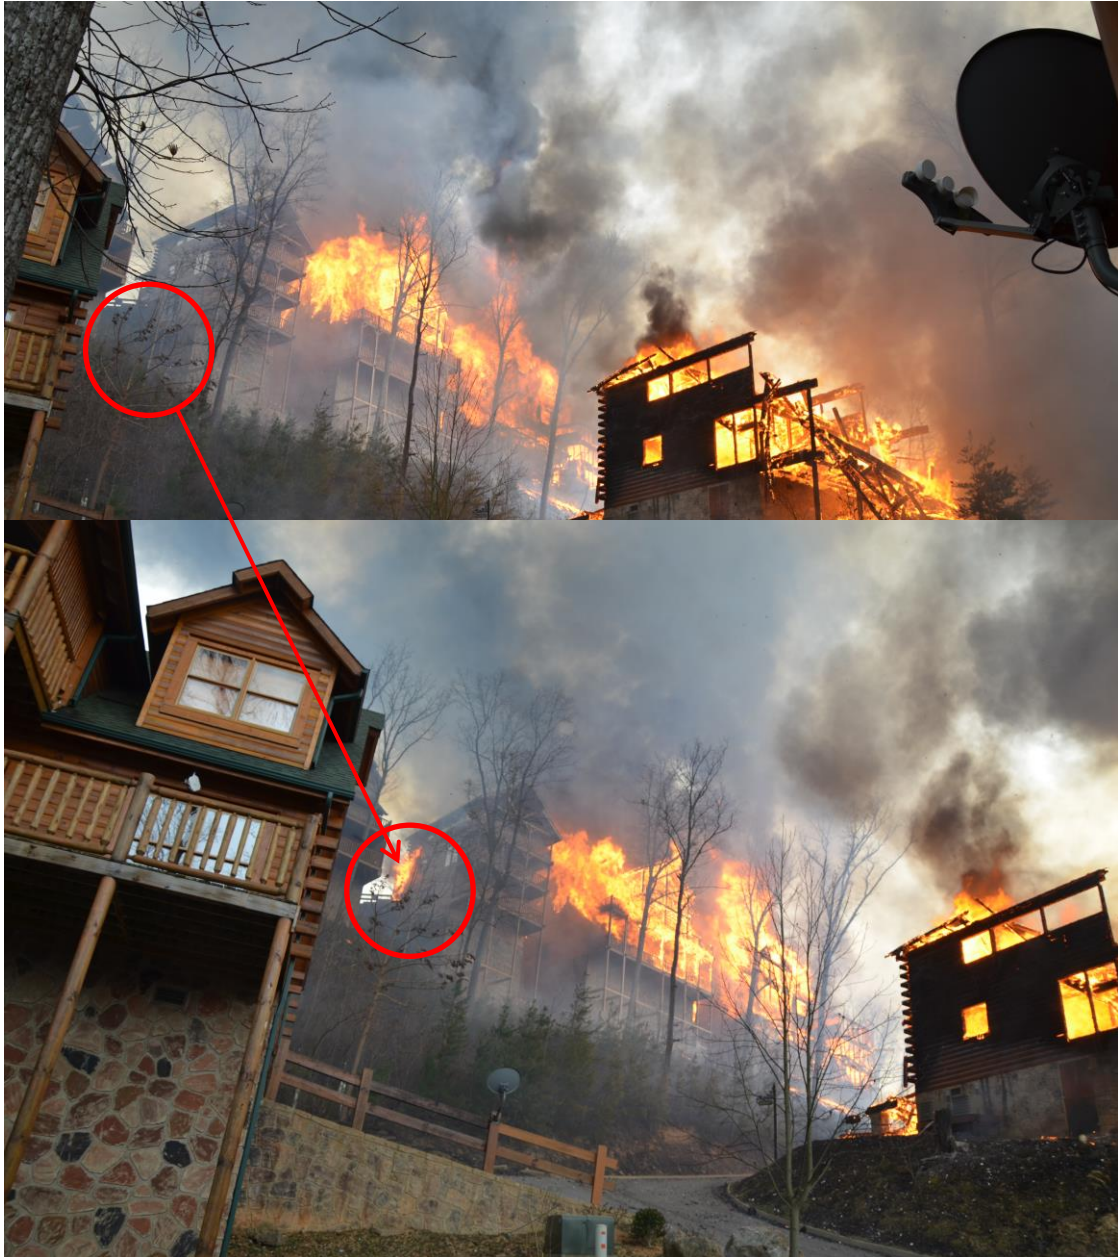
The effect of radiant heat resulting in building ignition and fire growth is seen in a series of photographs shown in Figures 2 and 3. The effect of radiant heat resulting in damage is shown in Figure 4. The between-building separation shown in Figure 4 was approximately 70 feet (see Autumn Path Way in Figure 1). The damage observed on this building consisted of scorch on combustible siding, cracked and broken window (annealed) glass, and deformed interior vinyl window blinds. Testing has demonstrated that heat flux of about  $10 \text{ kW/m}^2$  would be sufficient to break the outer pane of a dual pane (annealed glass) window (Cohen 1995; Babrauskas 2003). For comparison, this damage should be considered relative to the typical complete destruction of other cabin homes with much less between-building separation. The level and duration of the radiant heat exposure will determine whether ignition or other types of damage, such as broken glass in a window or door, occurs.

**Figure 2.** The first of two sequence figures taken by firefighters showing the growth of the fire at the front of a cabin. Note that in this figure and Figure 3, the circled areas are showing the same relative area. Photo credit: Chris Knutsen, Training Captain, Pigeon Forge Fire Department

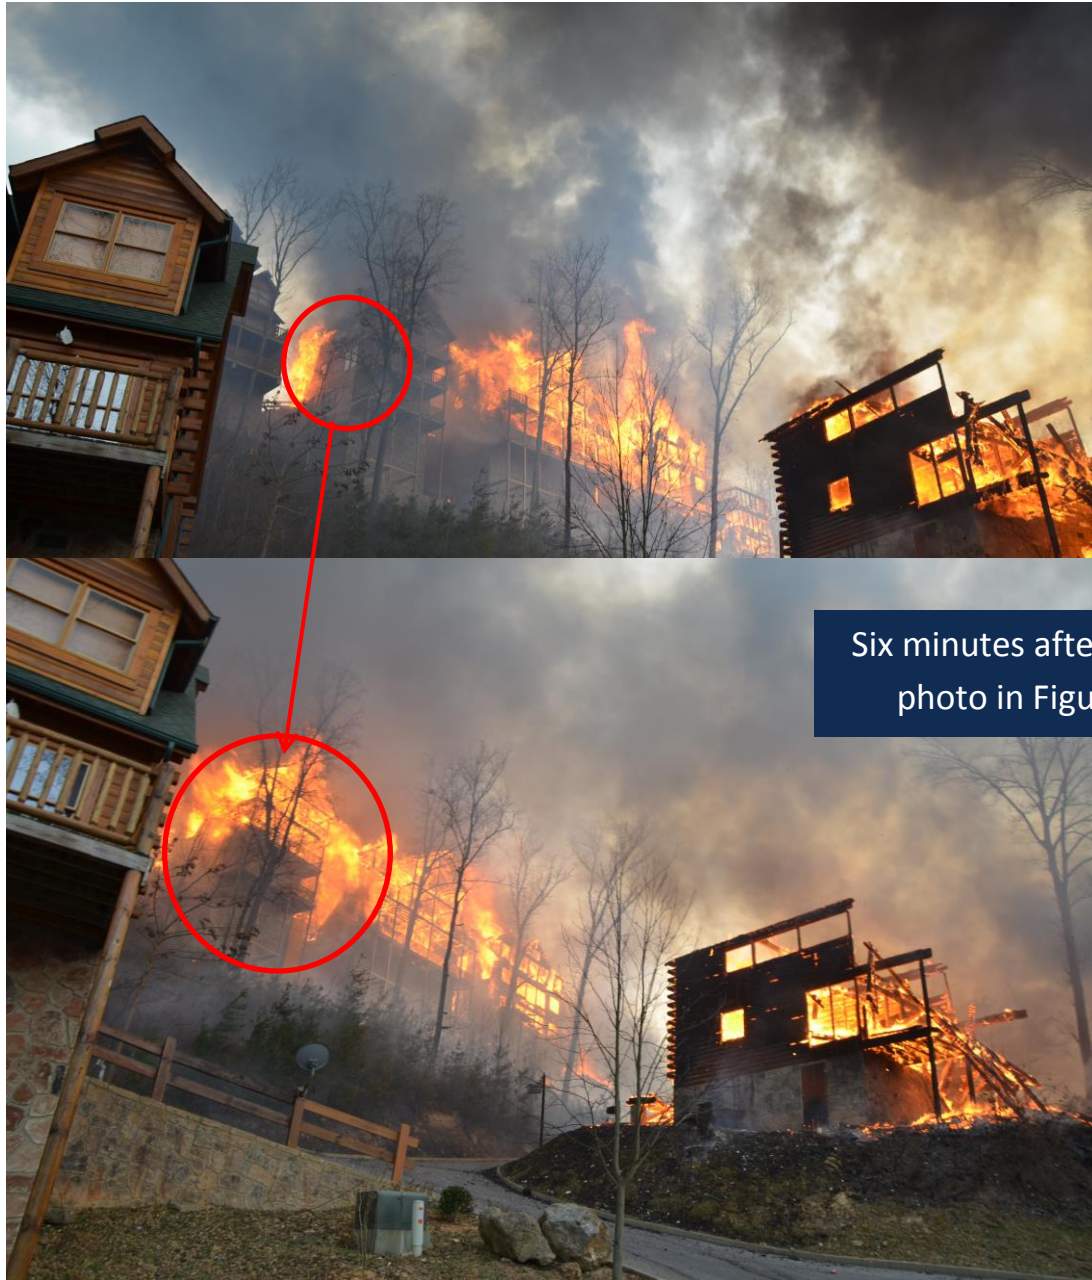
**Figure 3.** The second of two sequence figures taken by firefighters showing the growth of the fire at the front of a cabin. Note that in this figure and Figure 2, the circled areas show the same relative area. Photo credit: Chris Knutsen, Training Captain, Pigeon Forge Fire Department

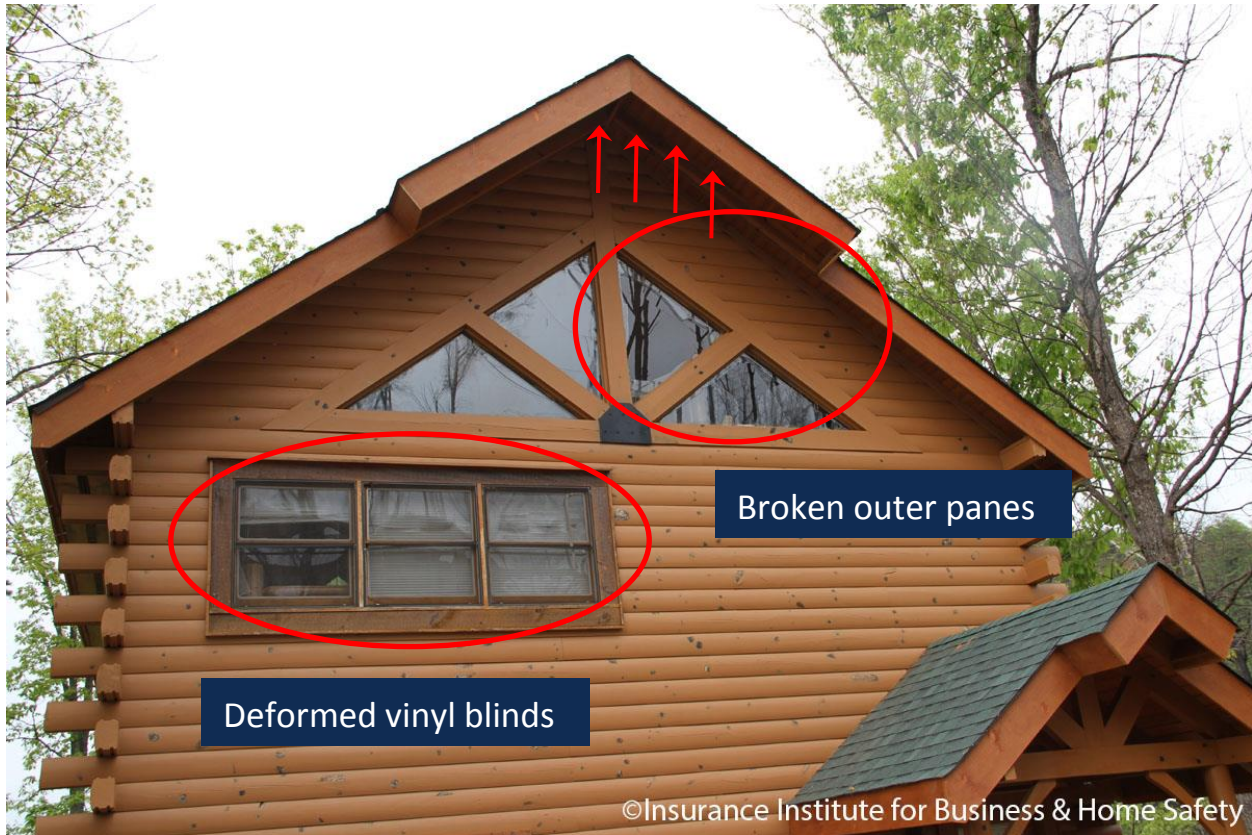
**Figure 4.** Radiant heat exposure resulting in damage to a cabin 72 feet from a burning cabin. In this case, damage consisted of broken glass in the outer pane of a dual pane window and deformed vinyl blinds.

Furthermore, the between-building separation shown in Figure 4 was approximately 70 feet, and it was downslope of the nearest cabin that burned, thus slope was not a contributing factor. The damage observed on this building consisted of scorch on combustible siding, cracked window glass, and deformation of vinyl window (interior) blinds. This evidence suggests that a minimum separation distance of 70 feet is prudent for this type of exterior and interior construction, if no other mitigating measures are employed, since an adjacent burning building produces so much heat.

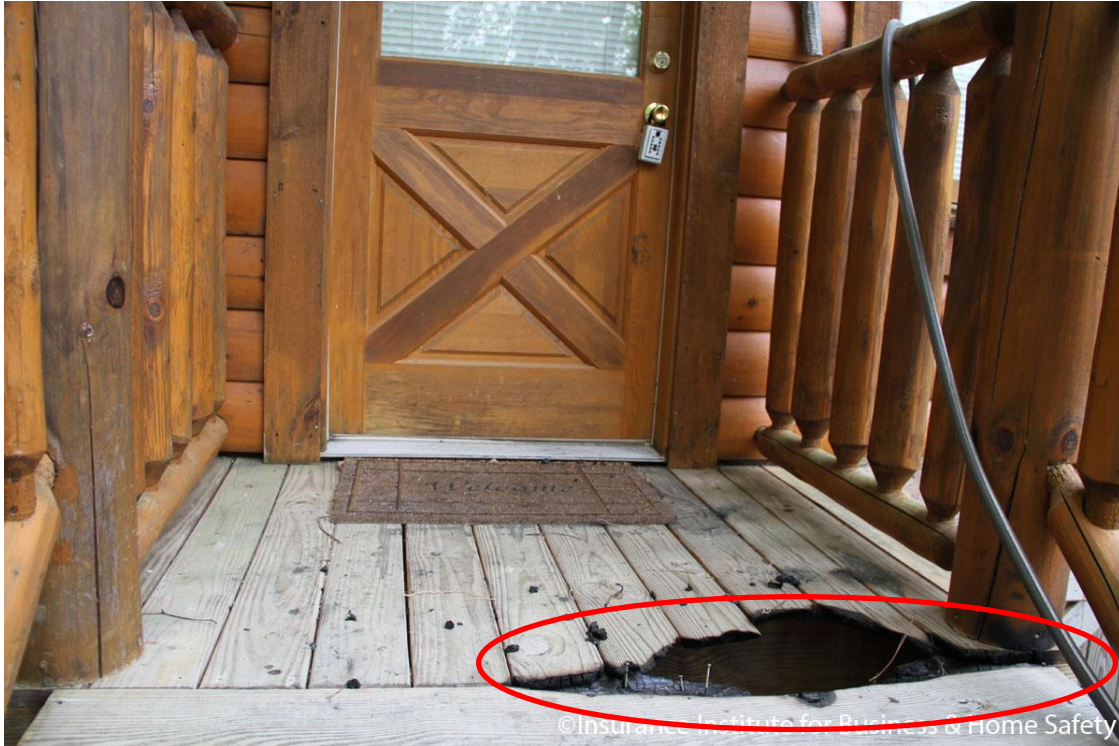
An example of a probable ember ignition, in this case a deck, is shown in Figure 5. An accumulation of embers on a debris-free deck, or in the between-deck-board gaps, could have resulted in ignition (referred to as a direct ember ignition). Another possible scenario would be an indirect ember ignition whereby embers ignited debris (pine needles, twigs, leaves) that had accumulated in the gap between deck boards or other locations on the deck, such as against a wall. In these cases, whether or not fire growth occurred or self-extinguished (or was put out by a firefighter) will determine the extent of damage caused by the ignition. A photograph taken during the evening showing embers produced by a burning house is shown in Figure 6.

**Figure 5.** Evidence of likely ember ignition on an entry deck (circled area).

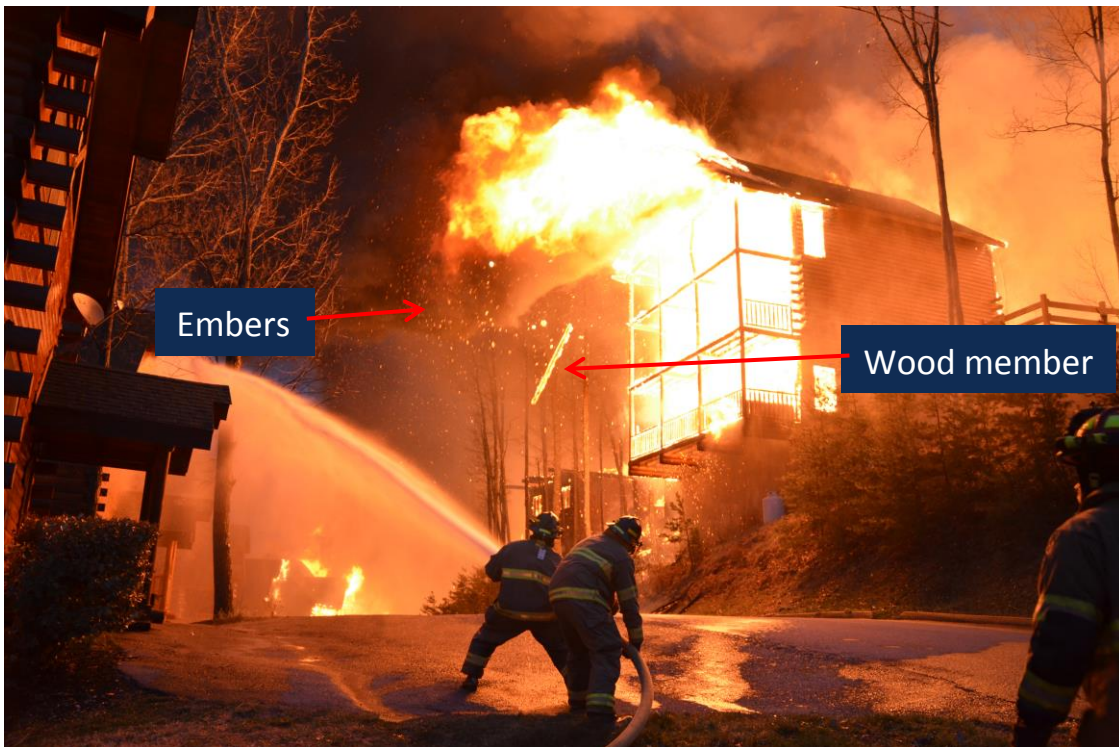
**Figure 6.** Embers produced by a burning cabin. Also shown is a flaming wood member that has detached from some component of the cabin. Photo credit: Chris Knutsen, Training Captain, Pigeon Forge Fire Department

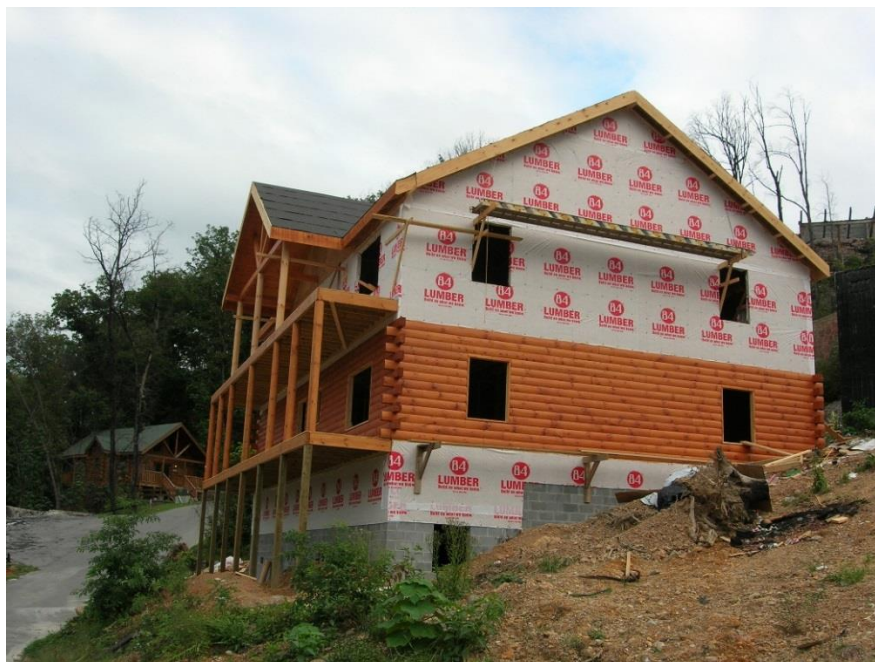
The construction in this development was referred to as log cabin. As seen in Figure 7, traditional log-wall construction in these log homes was limited to one level, typically the main walk-in level. The balance of the occupied floors was traditional wood-frame construction that were clad with a solid wood siding product having a rounded profile to resemble a log.

**Figure 7.** Common construction at Black Bear Ridge Resort consisted of log-wall construction on one level and wood-frame construction on other occupied levels, as shown in this photograph of a cabin being re-built after the Black Bear Cub fire. Note the concrete masonry unit (CMU-block) walls used for the foundation. Photo credit: Leon Konz, Wildfire Mitigation Specialist, Tennessee Division of Forestry

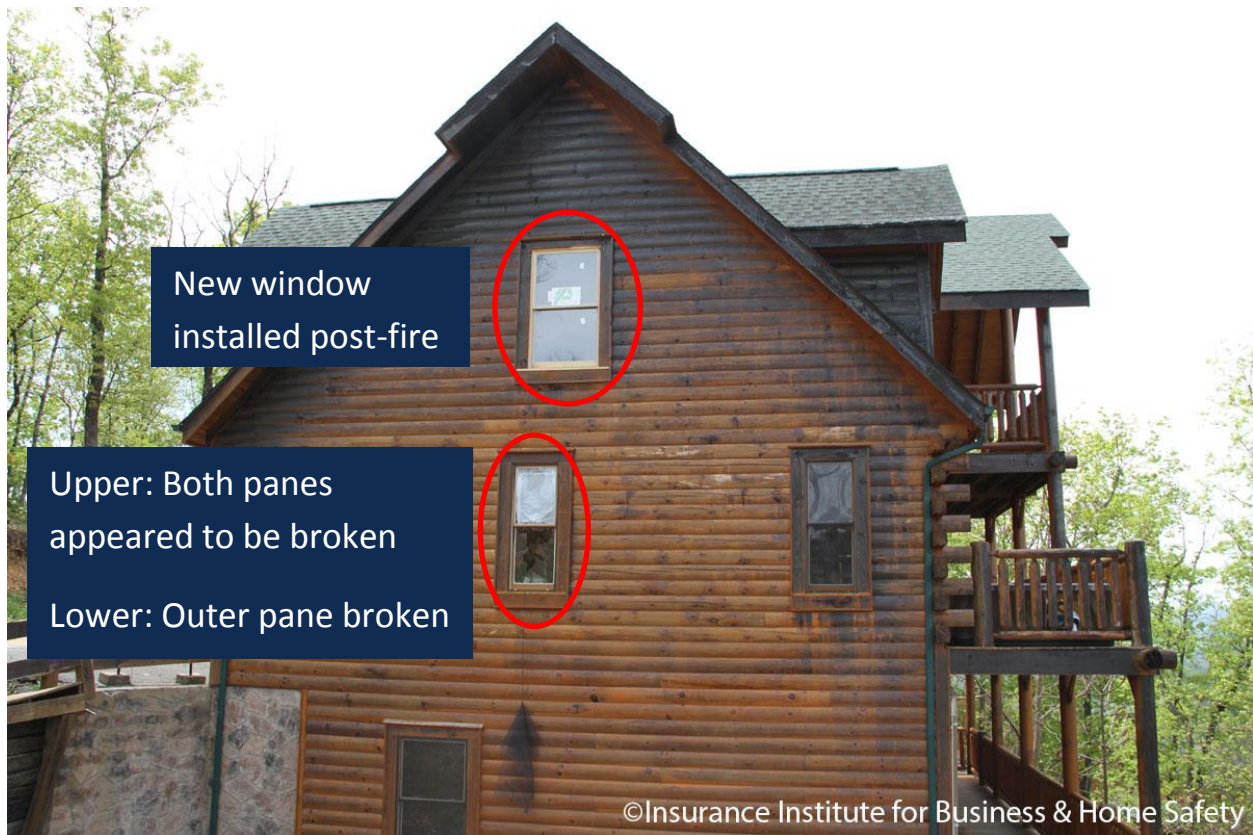
Vertical surfaces, including siding and windows, were vulnerable to radiant heat exposures (Figure 9). Given that the BBRR development is an established community, adjusting building spacing would be difficult. Based on the measurements made during the site visit, the between-building spacing ranged between 20 and approximately 40 feet. These distances are less than the building separation requirements specified in Section 6.2 of NFPA 1141 (NFPA 2012). This section specifies that unless governed by other locally adopted regulations, between-building separation for buildings located on two different properties shall be a minimum of 60 feet. This 60-foot distance includes the required 30-foot setback from property lines. Given the typical 50-foot x 50-foot lot size in the BBRR development, and the typical footprint of a cabin, consistently achieving the 60-foot building-to-building separation specified in NFPA 1141 (2012) would not be possible. It should be noted that Section 6.2.1.1 in NFPA 1141 allows for building separation to be reduced to 15 feet if both homes are protected with automatic sprinkler systems meeting the requirements of NFPA 13 (Standard for the Installation of Sprinkler Systems).

**Figure 9.** Radiant heat exposure that resulted in glass breakage in windows and scorch to the siding, particularly near the under-eave area on the rake end of the cabin.

Heat damage to the side of a cabin is shown in Figure 9. The window in the upper most floor appeared to have been installed since the fire since the manufacturers label is still attached to the glass. (The condition of the old window is not known.) Observed damage included broken glass in the upper and lower lights of the hung windows and scorch to siding and other wood members (e.g., deck framing and rails, and window trim). The plastic-clad fiberglass screen also detached from the center window on the middle floor. It appeared that the screen covered the entire window. Based on the Google Earth estimated between-cabin distances (Appendix A), the adjacent destroyed cabin was approximately 32 feet from the damaged cabin shown in Figure 9.

Breakage of both panes of a dual-pane regular annealed (non-tempered) glass in the windows would indicate that a minimum exposure of approximately  $35\text{-}40\text{ kW/m}^2$  occurred for at least three to four minutes. Based on measurements and observations made on site, radiant heat exposure sufficient to break the outer pane of dual pane unit was possible at a cabin-to-cabin distance of approximately 70 feet. At similar radiant heat exposures, wood siding products ignited (flaming combustion) at exposure times between 5 and 15 minutes (Quarles and Sindelar 2011). It appears that flaming combustion occurred on siding near the roof line and on the dormer on the back side of the cabin, and on the corner trim at the dormer, but it did not sustain. It is not known whether firefighters were in the vicinity, but the damaged cabin was one of the two transition cabins between destroyed and undamaged cabins.

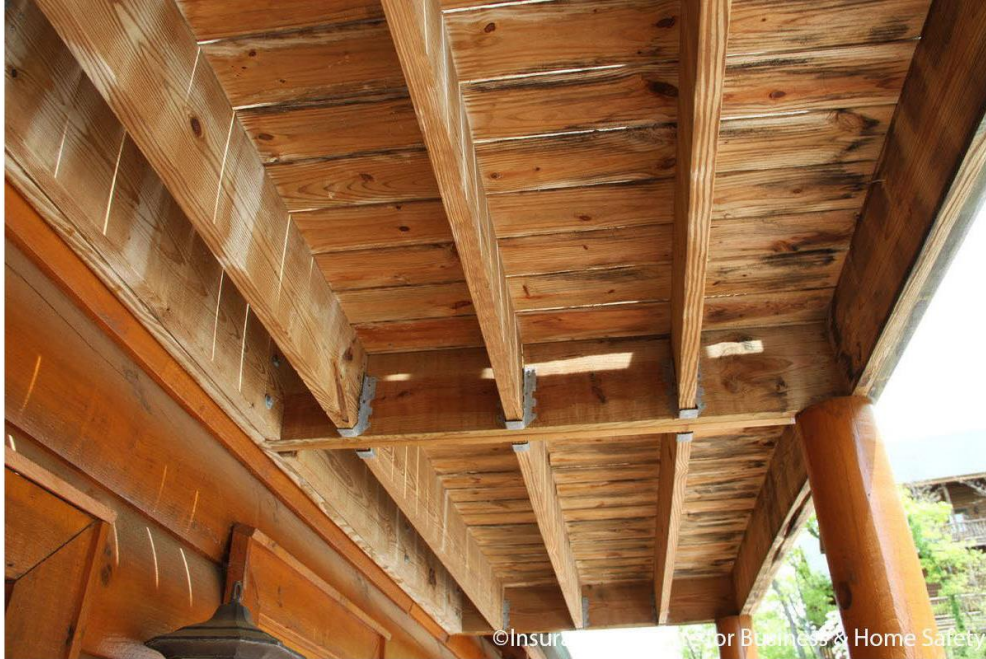
**Figure 10.** The under-deck structural support system in a deck will trap heat in the same way as under-eave open-frame construction.

- Exterior-rated, pressure-impregnated fire-retardant-treated lumber could be specified for the structural support members. Dual-treatments that provide both fire resistance and resistance to biological organisms are not available, but since it doesn't appear that lumber treated with a preservative is used for the structural support members, fire-retardant treated lumber and timbers could be considered.

- Decking could comply with the heat release rate (HRR) requirements of CBC Chapter 7A. Products that comply with the requirements of CBC Chapter 7A can be found on-line at: [http://osfm.fire.ca.gov/strucfireengineer/strucfireengineer\\_bml.php](http://osfm.fire.ca.gov/strucfireengineer/strucfireengineer_bml.php). This universal resource locator (URL) is a link to the California Office of the State Fire Marshal Building Materials Listing Program. Once at this location, the user can view current State Fire Marshal Listings. Information on deck boards would be found in the "Decking for Wildland Urban Interface" category.

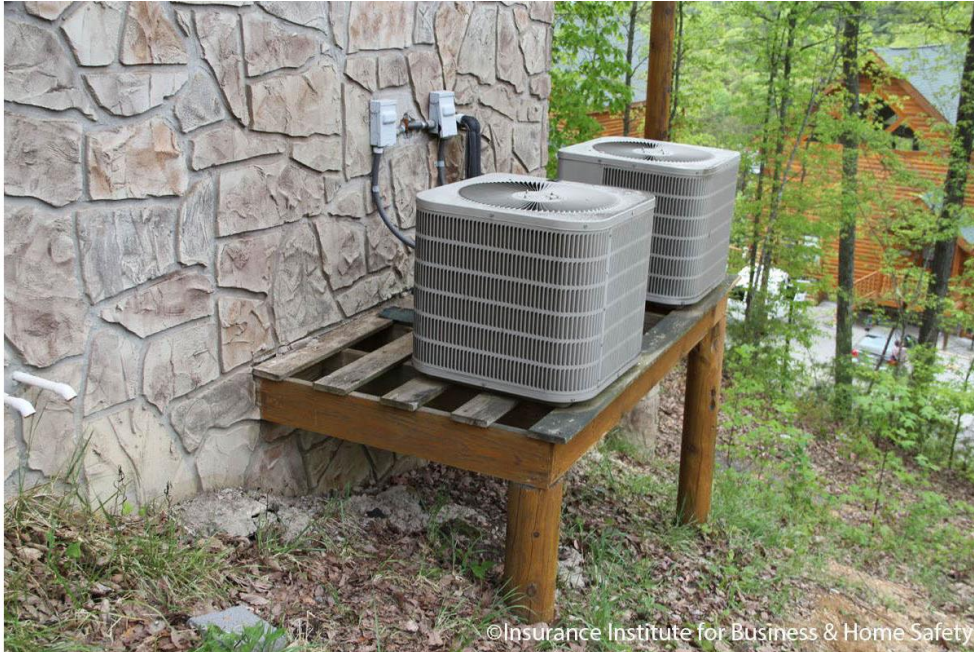
Small deck platforms were commonly used to support air conditioning units (Figure 11). These platforms were often close to the ground. As reported by firefighters, these often burned. It is unclear what affect this had on the ignition of the cabin, but a likely ignition scenario would include ignition of under-deck combustibles such as leaves. Removal of vegetative and other combustible items is usually a maintenance item, but a noncombustible zone could be created under these platforms, and around the entire building through the use of rock mulch. This is a common recommendation by many education and outreach organizations, including the NFPA Firewise Program. It is acknowledged that this would be difficult to maintain given the steep terrain in the area. Instead of a wood framed deck, an alternative design using a concrete pedestal could be used to support the air conditioning units.

**Figure 11.** Small platform decks were used to support air conditioning units.

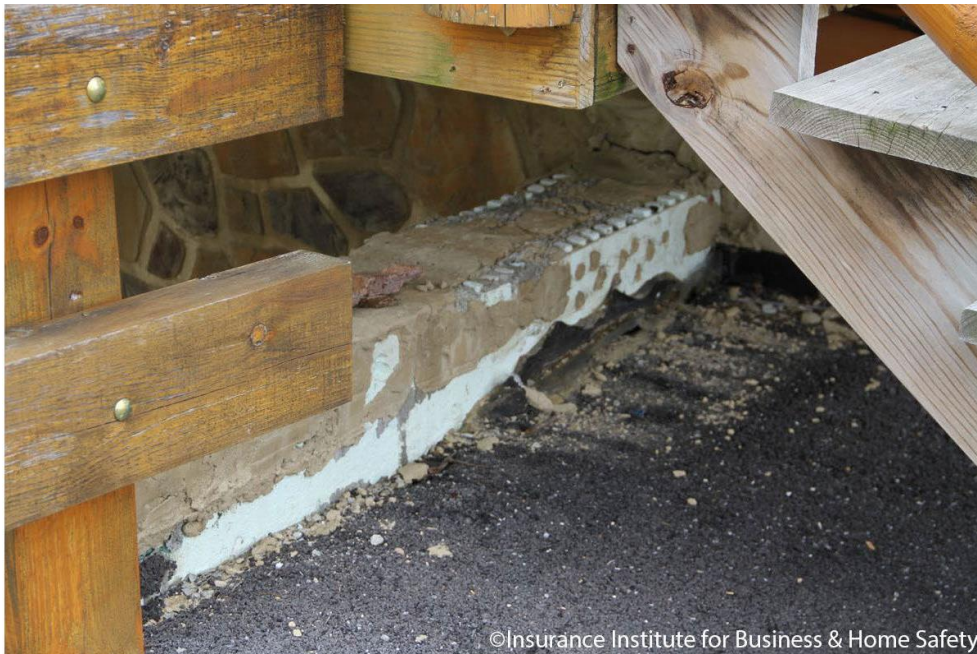
Concrete forms that incorporate foam insulation boards (insulating concrete forms/ICFs) were observed at different locations in the development (Figure 12). Ember accumulation at the base of these walls with exposed, unprotected rigid insulation board could result in ignition. In this example, flames from ignited foam could impinge on the underside of the stairs and deck. To protect this area from ember accumulation, a noncombustible surface, such as a piece of metal flashing, could be used at the ground-to-vertical surface interface.

**Figure 12.** Rigid foam insulation board used on the outside of this concrete form will be vulnerable to direct ember ignition.

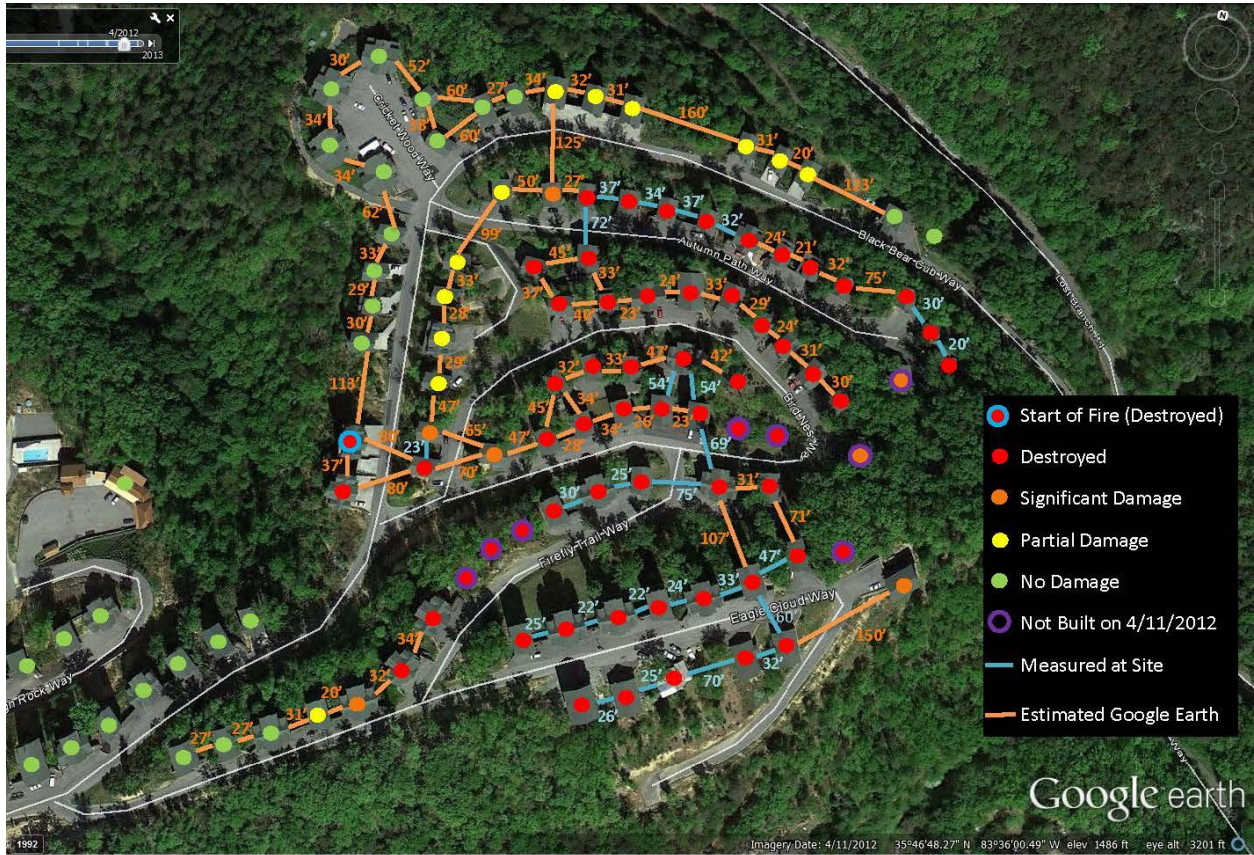
Between-cabin spacing, measured on site and estimated from an April 11, 2012 Google Earth image.
